MNM Fatal 2004 - 04

- Slip or Fall of Person (Indiana)
- February 26, 2004
- Crushed Stone Operation
- Maintenance Person
- 47 years old
- Six years experience

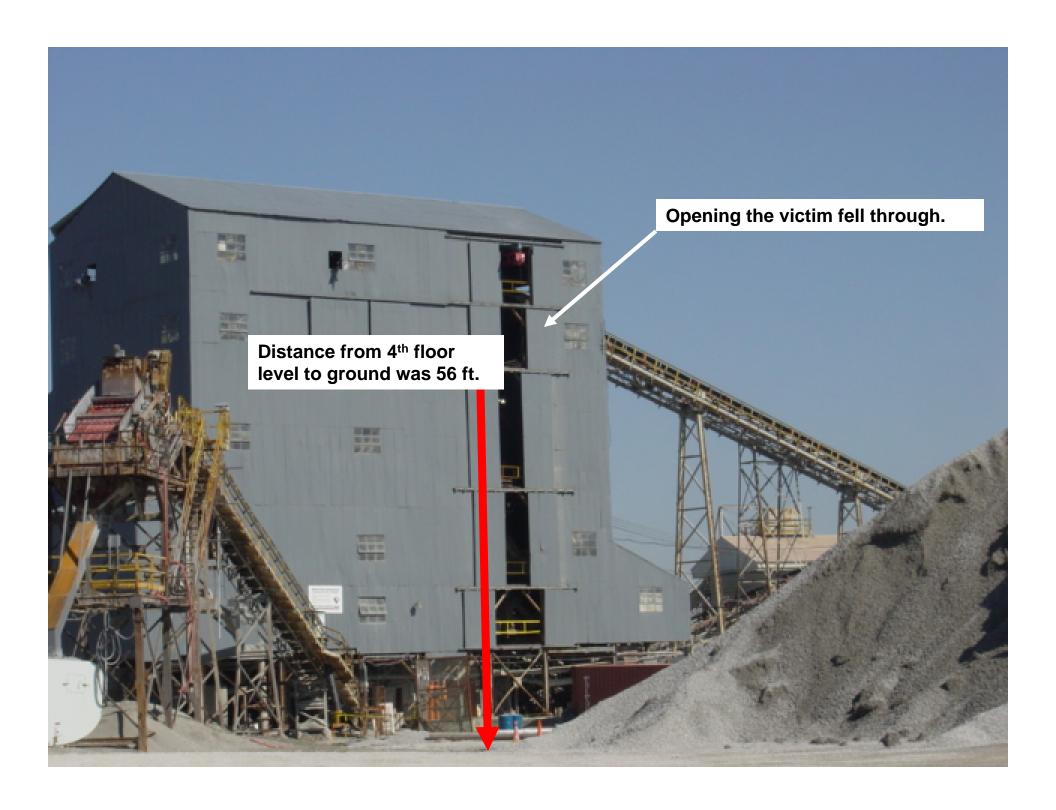
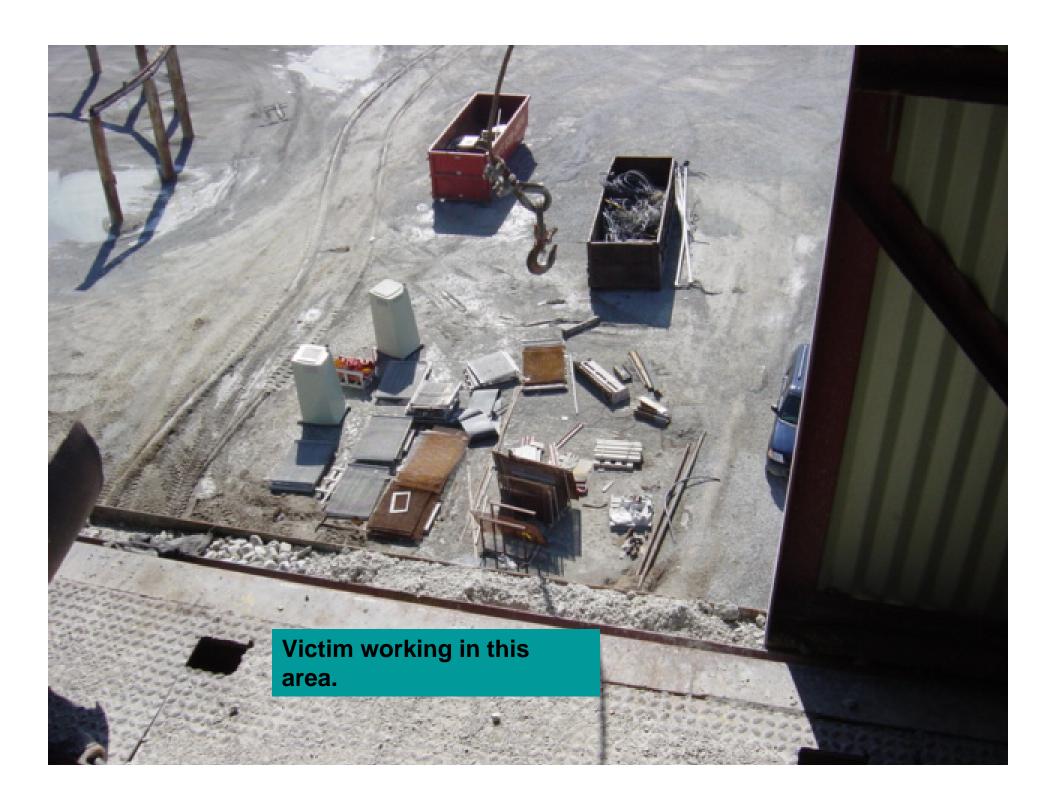
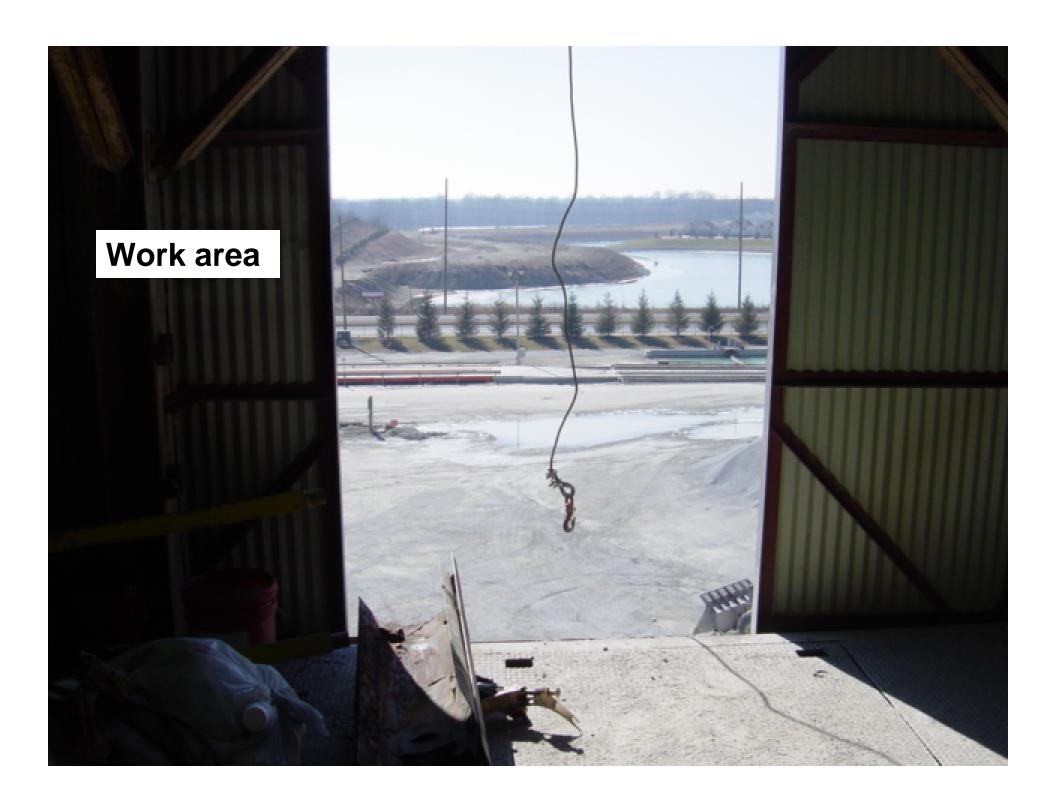
- Maintenance crew was dropping scrap parts through an open door from fourth floor of mill building.
- Barrier railing was removed so an overhead hoist could be used to remove a large piece of pipe.
- Victim lost his balance near edge of opening and fell 56' to the ground.

- Wear fall protection where there is a danger of falling.
- Conduct a risk analysis before starting a task to identify hazards and implement measures to ensure persons are properly protected.
- Train all personnel to help them recognize potential hazards and understand procedures to safely perform tasks.
- Monitor work tasks to reinforce safe procedures and obtain feedback from employees on the use of fall protection systems to ensure their commitment.

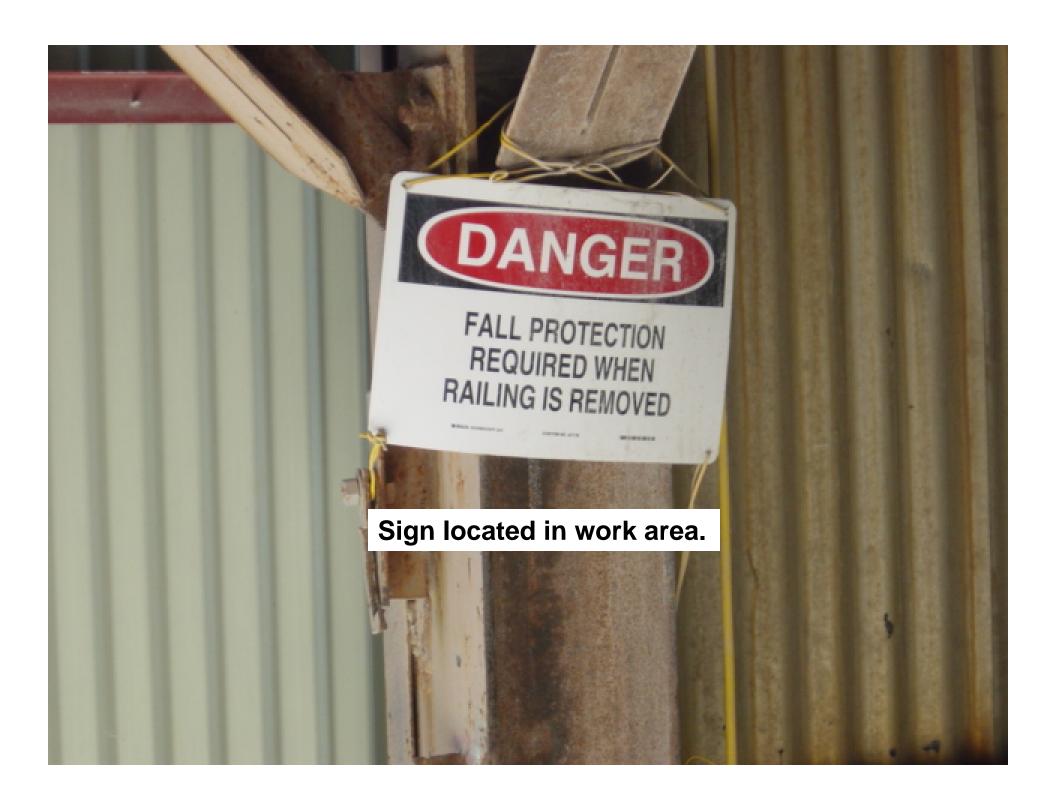
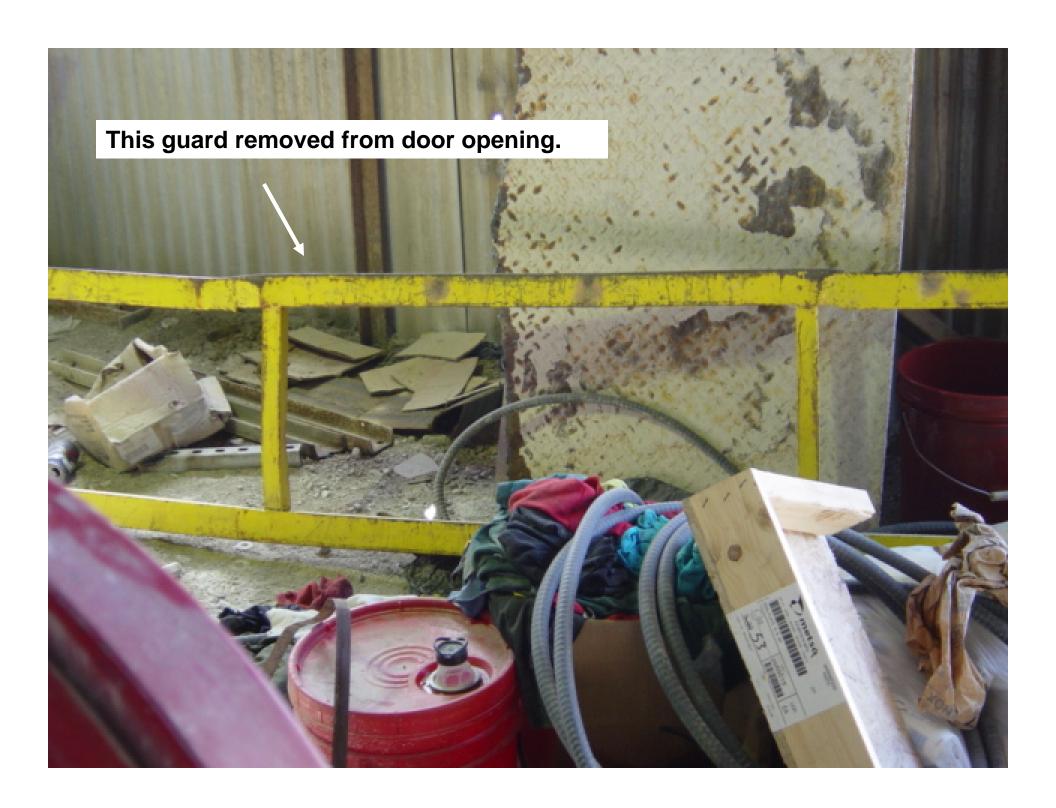
- Access door opened so small scrap parts could be thrown out.
- Barrier railing was removed so overhead hoist could be used to remove large piece of pipe.
- No fall protection used where there was a danger of persons falling.

- Victim had not taken safety harness and lanyard with him to the work site.
- Barrier railing removed.
- Procedures in place requiring fall protection to be worn when barrier railing was removed were not followed.
